SB, Rebuild kit, KV9/12, 2021-04

The newly introduced K1270 II does not fit the older KV9/12. For this reason the KV9/12 has been upgraded.

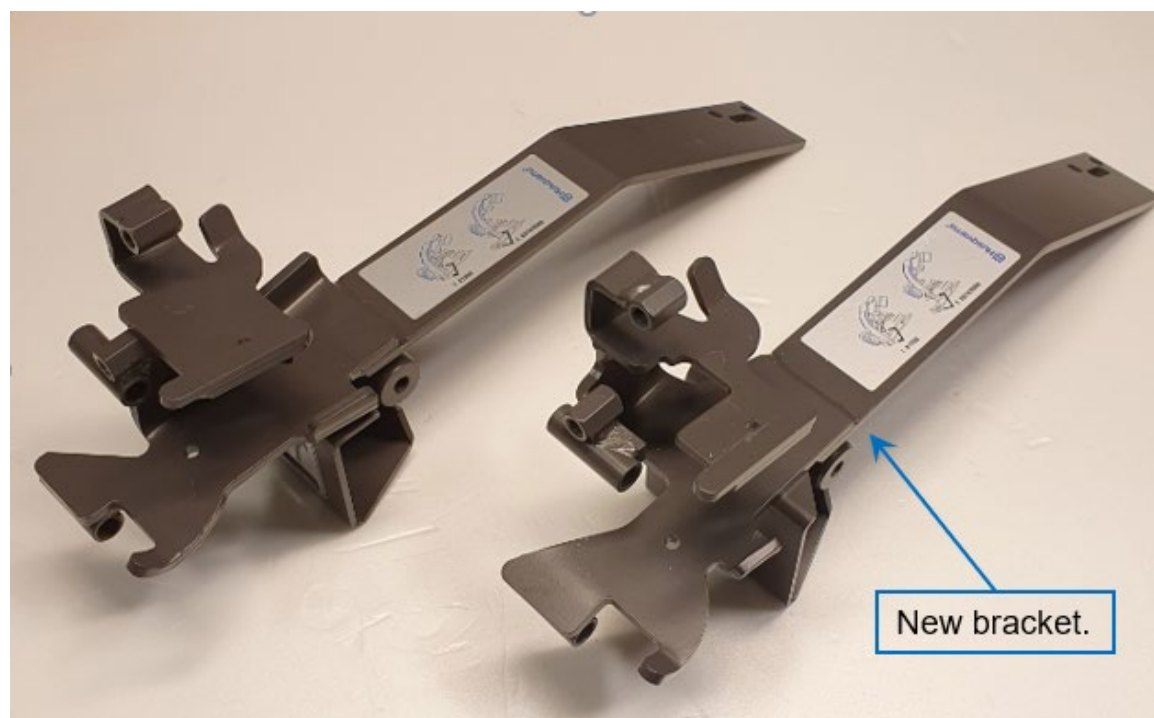
Figure 1: Old and new bracket.

Due to the new 1270 II Fuel Tank, an update of the welded bracket that holds the machine is needed. Below is an instruction how to rebuild the KV using the upgrade kit.

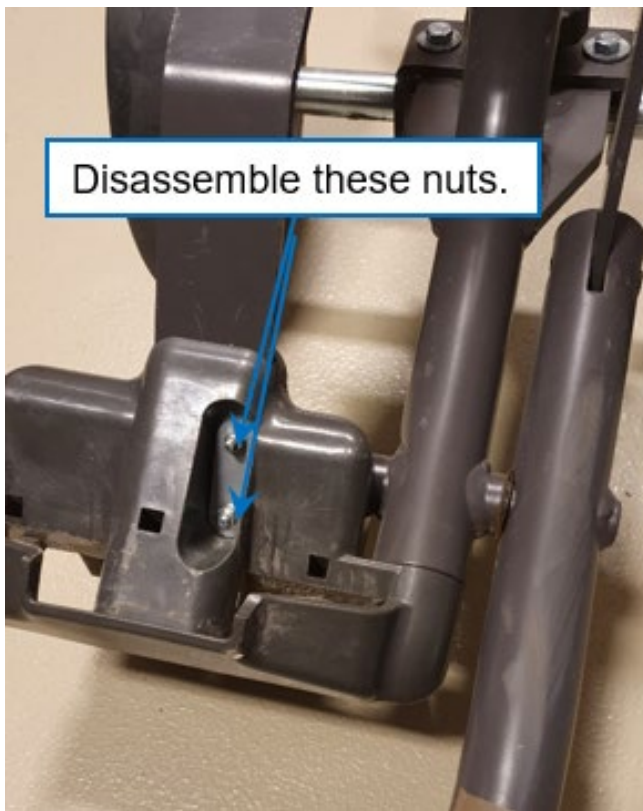
Figure 2: Nuts to disassemble.

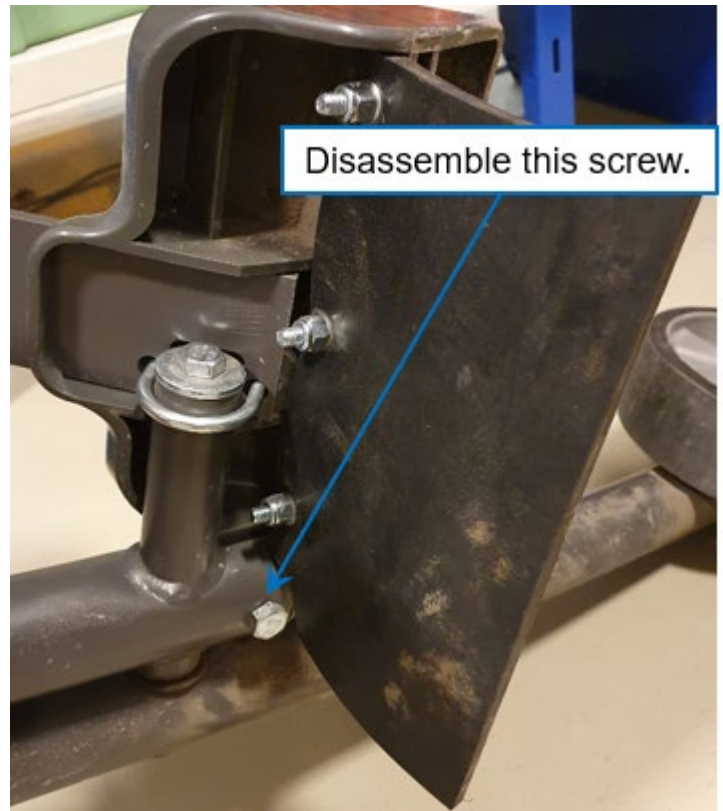
Figure 3: Screw to disassemble.

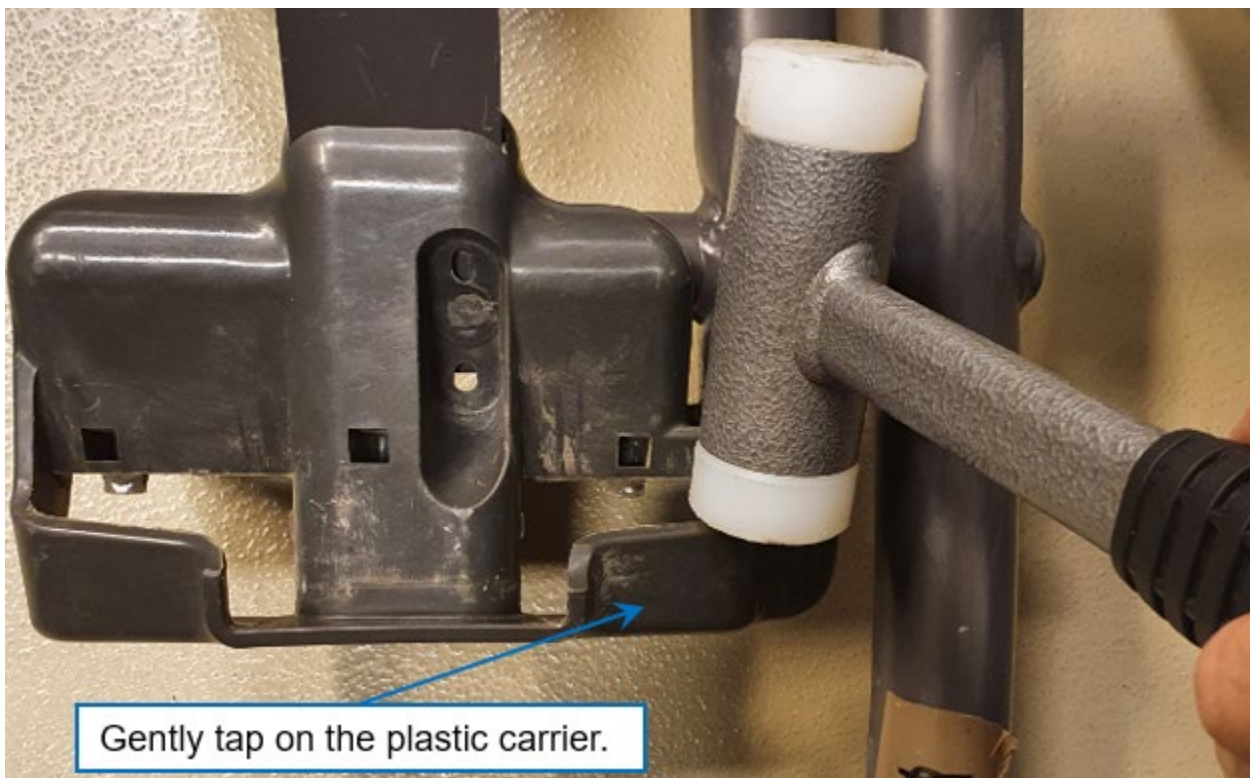
Figure 4: Tap on the carrier.

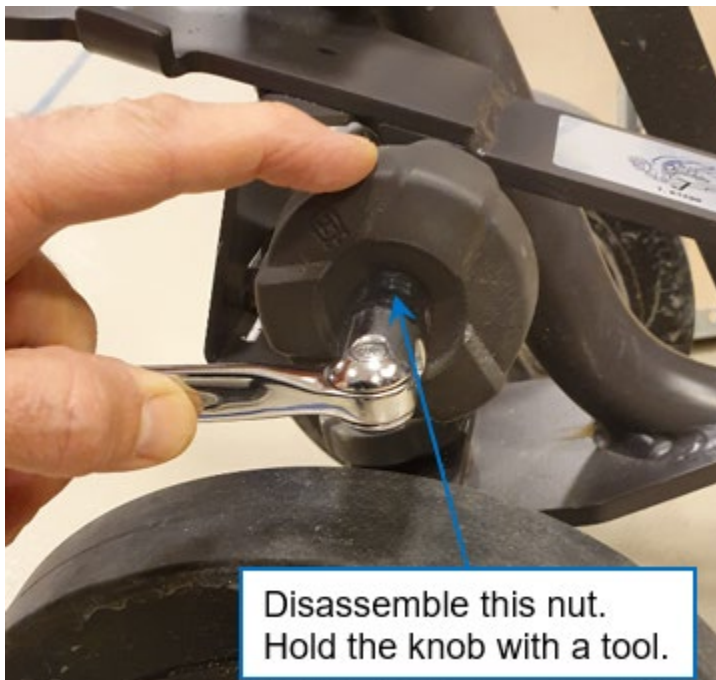
Figure 5: Disassemble the nut holding the knob.

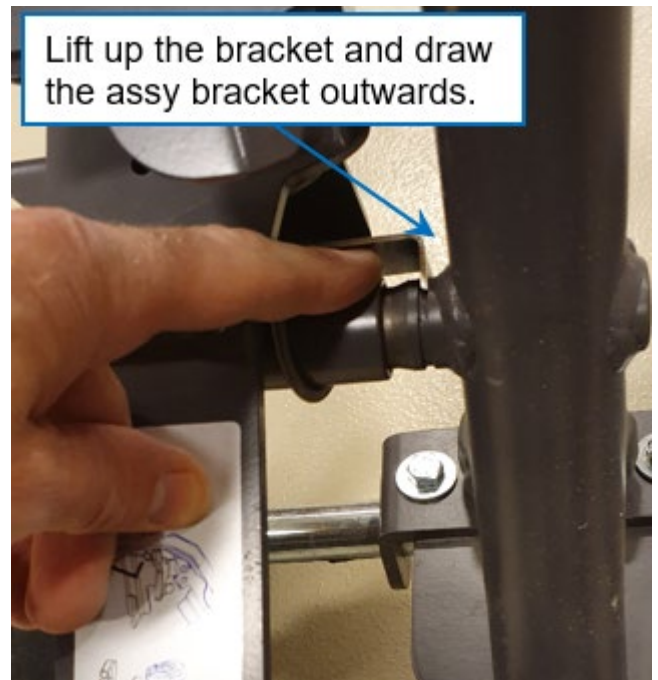
Figure 6: Pull the bracket outwards.

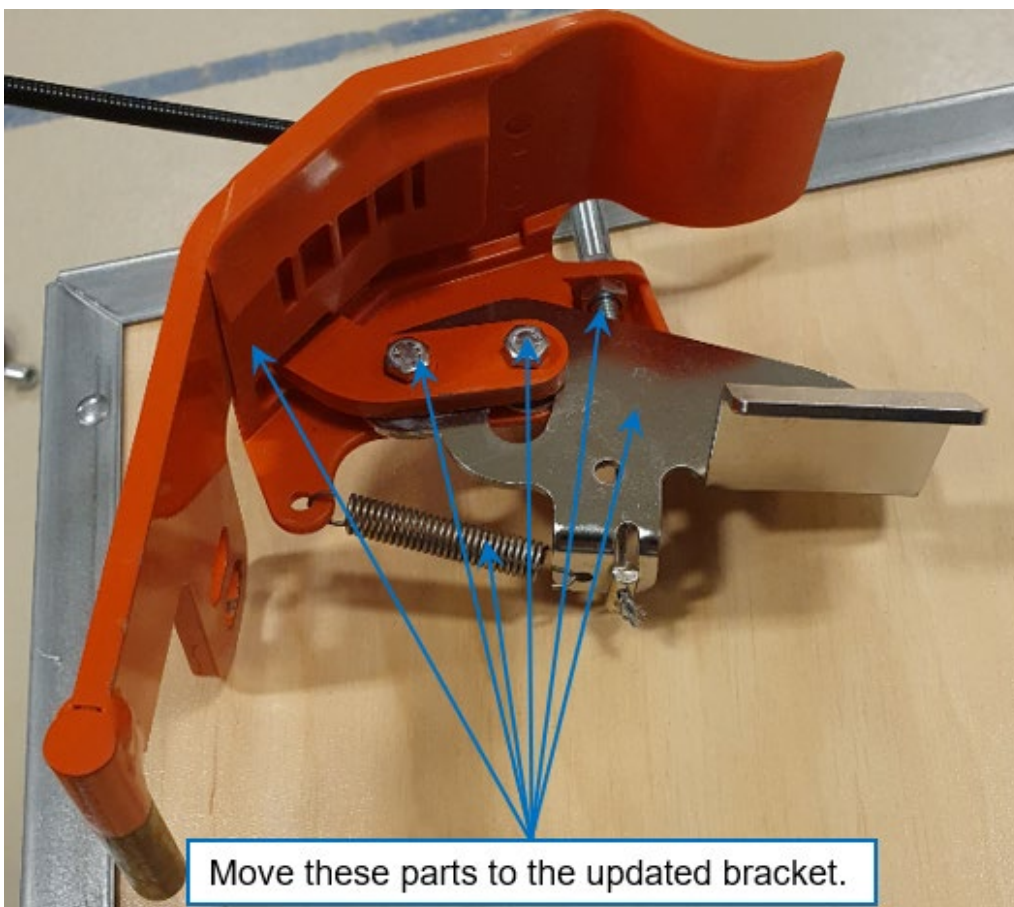
Figure 7: Parts to be moved and used with the new bracket.

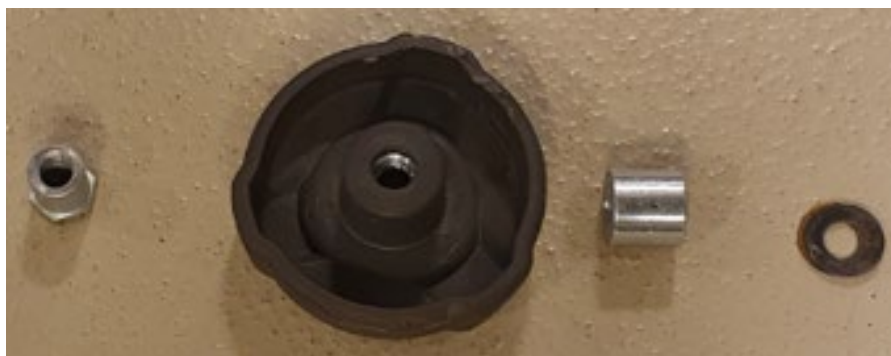
Figure 8: Turning knob.

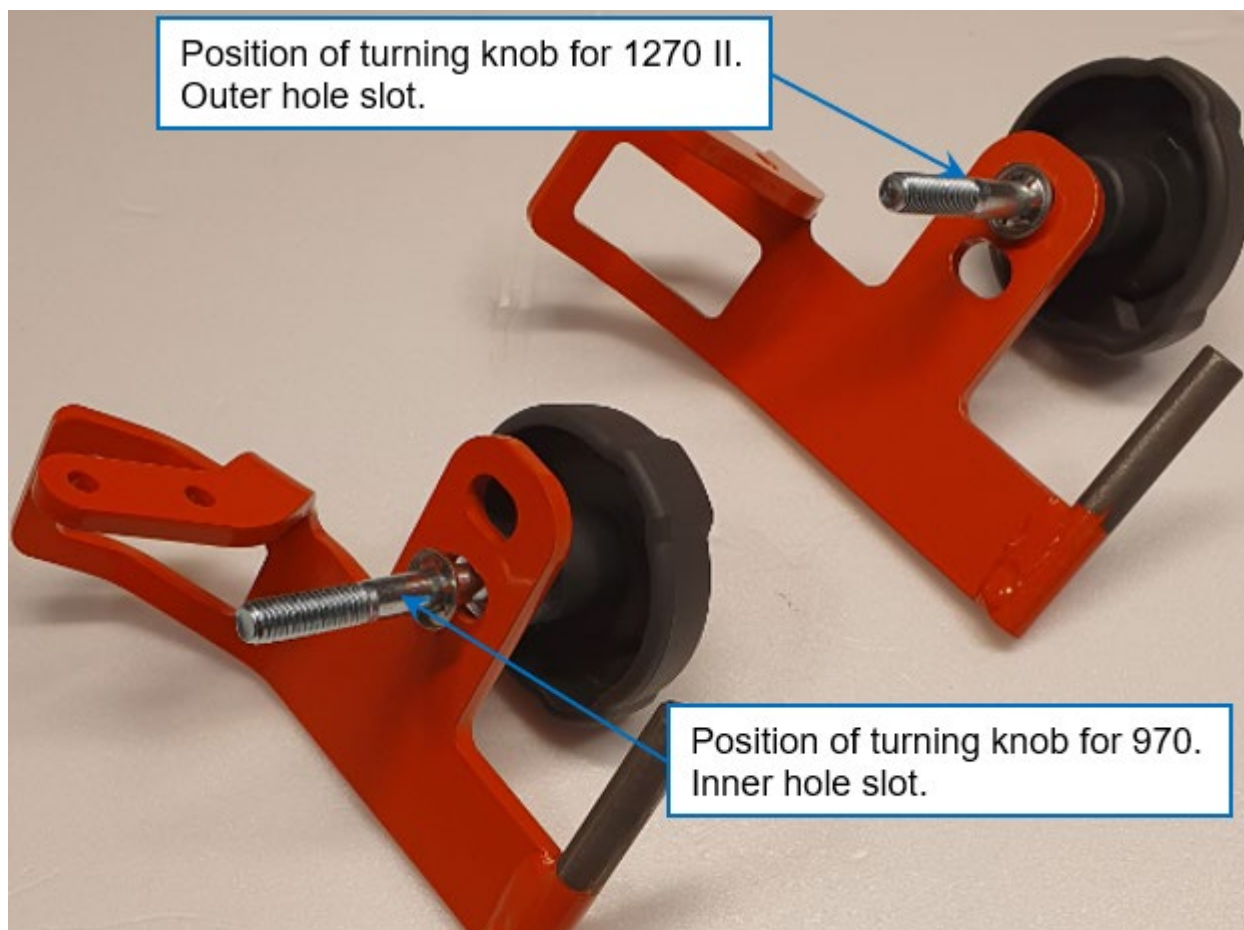
Figure 9: Position of turning knob.
